# BUILDING INVESTIGATION

## ST MARY'S CHURCH DEVIZES

09 April 2013

## Building Investigation – St Mary's Church, Devizes

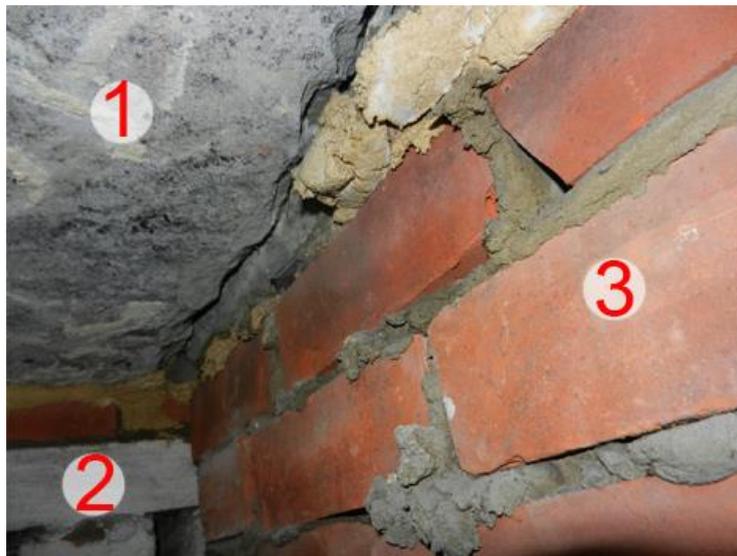
Figure 1

Photograph of underside of side aisle showing:

1. Underside of ledger
2. Ventilated brick wall running east west.
3. Brick cross wall supporting ledgers and slabs.

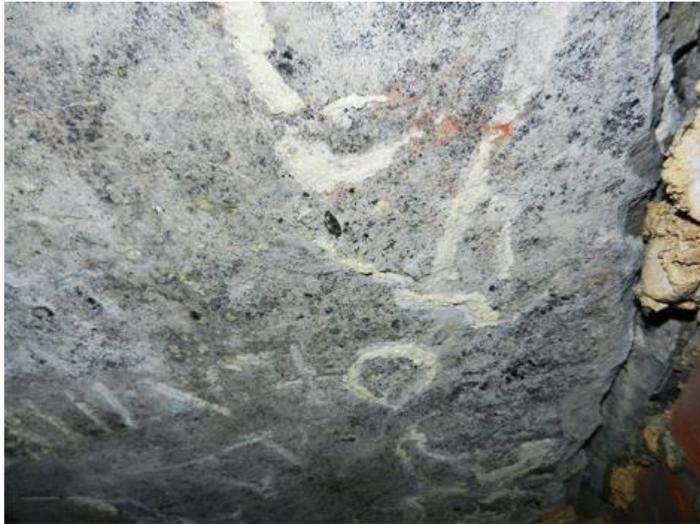
Figure 2

Some of the ‘slabs’ used in the side aisle have lettering cut into the underside, indicating that they are actually ledgers that have been inverted and re-used.

Photograph of underside of ledger in side aisle, showing incised lettering.

It is clear that the ledgers have been re-sited and in in at least some cases inverted so that the inscriptions are now obscured.

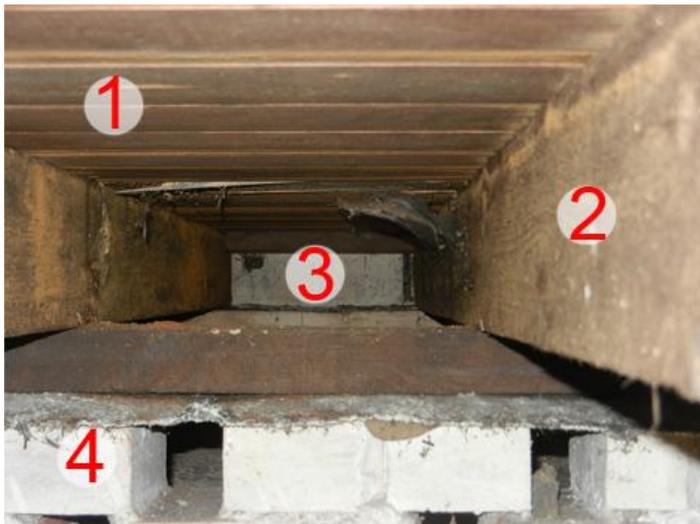
Figure 3

Photograph of underside of timber floor, showing:

1. Underside of floorboards
2. Joist running north south
3. Solid brick wall adjacent to central aisle
4. Ventilated brick wall at approx. mid-width of timber floor, and running east-west.

There is no evidence of any significant degradation in the timber, although in many places, the moisture content on the joists and underside of the floor boards is 20-22%mc, which is close to the level at which fungal activity can survive. In one location adjacent to the central aisle, there were free water droplets on the underside of one plate. The general conditions in the sub-floor voids would not normally generate this sort of condensation, and the source and cause of these water droplets cannot be determined.

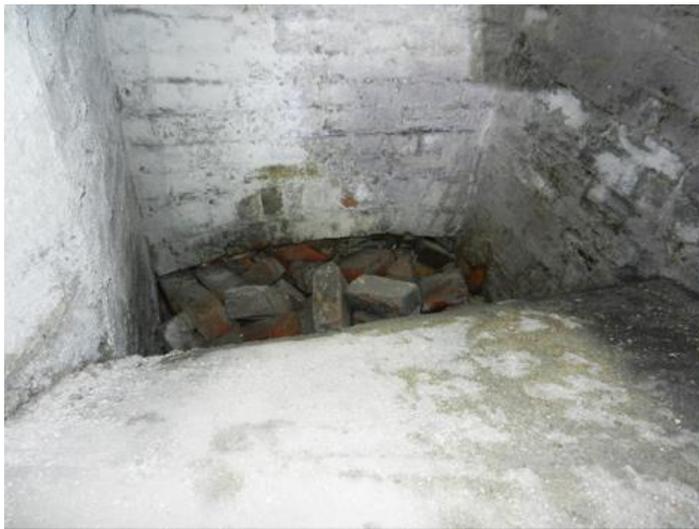
Figure 4

The ducts seem to drop down to the basement boiler room, but the ducts are now bricked up and partially filled with loose bricks – presumably when the heating system was changed to a piped wet system.

Photograph of heating duct where it drops down towards the boiler room in the basement.

The duct has been bricked up and partially filled with loose bricks.

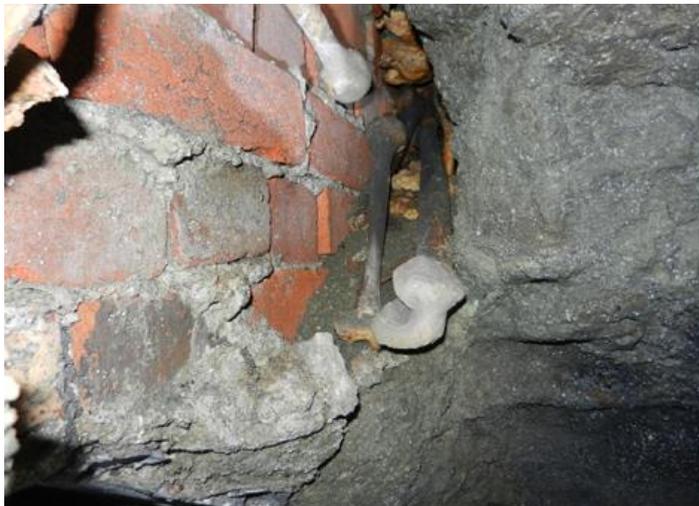
Figure 5

In the small chamber the leads off to the west from the basement boiler room, a number of human bones including a skull have become exposed, presumably by disturbance to the chamber roof.

Photograph of chamber to west of boiler room showing human bones, including a skull
