What's under the floor in St Mary's?

Archaeological investigations in preparation for the renovation project.

As part of meeting Planning Condition 8, Context One Heritage & Archaeology recorded the excavation of twelve trial holes and two boreholes at the Church of St Mary the Virgin, New Park Street, Devizes, Wiltshire in November 2020

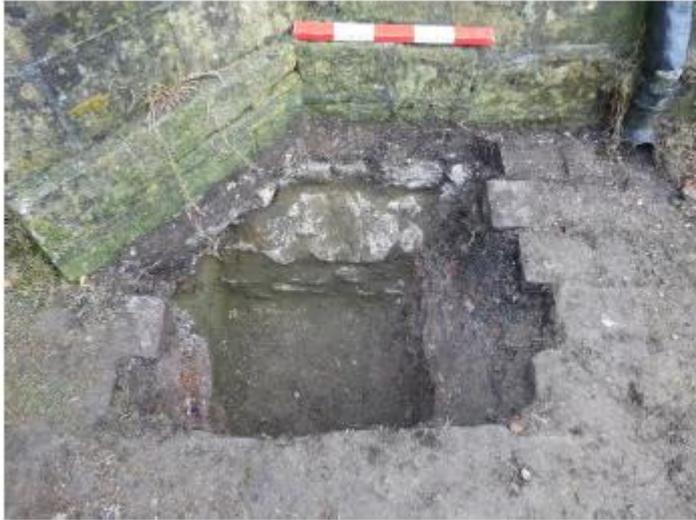
The **three exterior trial holes** exposed some of foundation to the church. The chancel, vestry and eastern wall of the north aisle had well-constructed foundations of c. 0.70-0.75m depth, whereas the north aisle foundation consisted of greensand and rubble to a depth of 0.65m. Reference to this can be found in the Devizes and Wiltshire Gazette 24th February 1898 report that 'important work was done in the way of concreting round, but not under the foundations'. It may be the case that no archaeological remains survive adjacent to this side of the church. Similarly, the construction trench for the vestry, built as part of the 1854 restoration, has removed any archaeological deposits immediately north of the chancel.

Figure 5. TH3 (looking S; 0.5m scale)

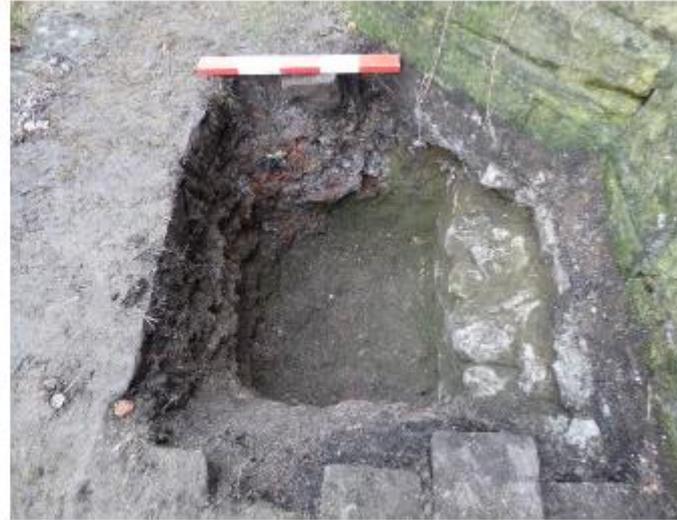
Figure 6. TH2 (looking E; 0.5m scale)

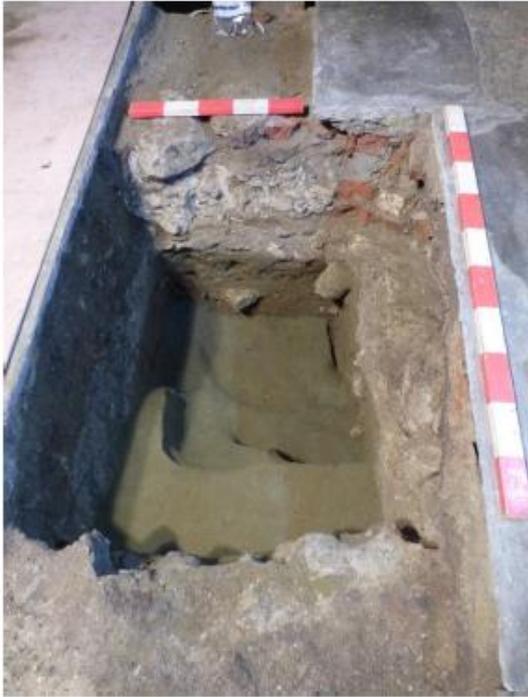
While the extensive 1854 restoration appears to have removed any earlier floors or horizons, cut features and structural remains have been identified within the proposed 0.60m impact zone. These mostly relate to burials at depths of 0.50m, however in most cases only the upper part of the grave cuts will be impacted and the fills have been previously disturbed. It is anticipated that most of the associated skeletons will lie deeper within the graves and will not require excavation, although the discovery of a single partially articulated skeleton at a depth of 0.40m may not be the only case of a burial within the impact zone. Crucially, the evidence for intercutting burials and a coffin burial in front of the chancel arch suggests that the proposed deeper groundworks at the east end of the nave will encounter intact burials. Under the tower excavations show an intact brick vault that is under a large 18th century ledger stone. This would mean the lowering of the vault walls and inverted excavation of the soil (containing coffin furniture) adhering to the vault roof. Also, given that the vault likely still contains the decayed coffins and remains of the four occupants it would be preferable to re-set the ledger stone in the same location. Finally, the identification of some possible pre-15th century foundations suggest there may be some potential for identifying evidence for the

Figure 7. TH7 showing intercutting graves below hardstanding for former pulpit (looking W; 0.5m & 1m scales)

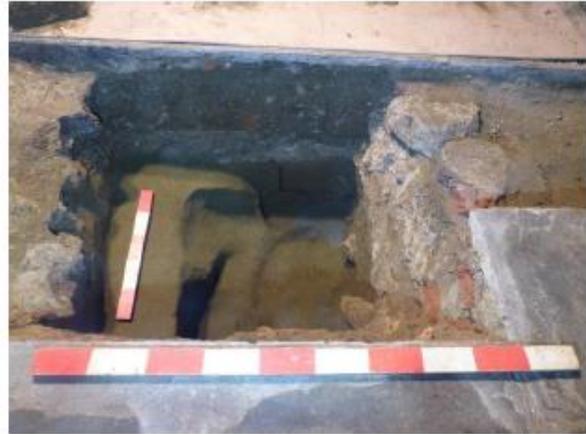
Figure 8. TH7 showing intercutting graves & intact coffin in S section (looking S; 0.50m & 1m scales)

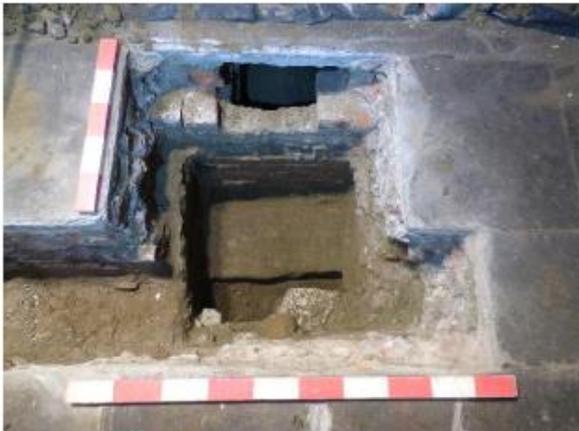
Figure 9. TH8 showing vault & walls (looking S; 0.5m & 1m scales)

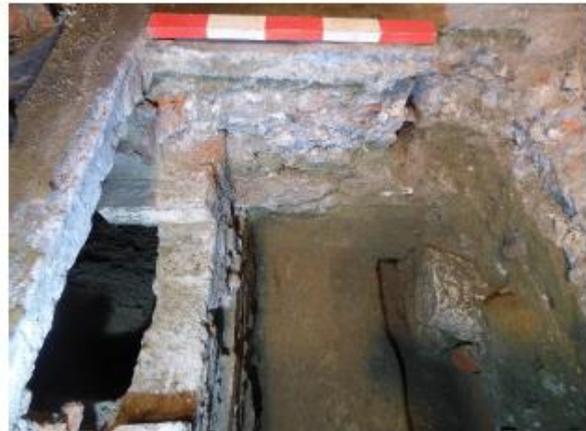
Figure 10. TH8 showing vault & walls (looking W; 0.5m scale)
