Study St Mary's Churchyard

1 Introduction

The objective of this document is to look at recent burial activity in the churchyard that might be affected by any building works on the north side of the church. The previously commissioned Historic Assessment (Section 4) has been studied and visits made to the Wiltshire and Swindon History Centre (WSHC). The Wiltshire Family History Society has been contacted and the Monumental Inscription record produced by them has been inspected on fiche at the WSHC.

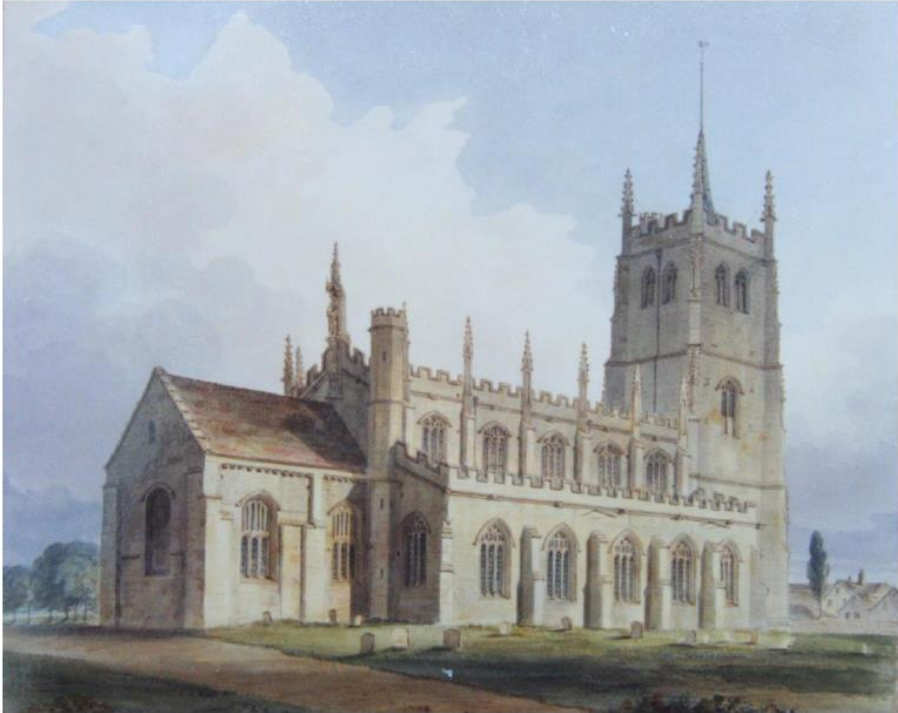
John Buckler's view of St. Mary's from the North East in 1809. Note the large 15th century east window and the curve of the lintell above the blocked north door to the chancel.

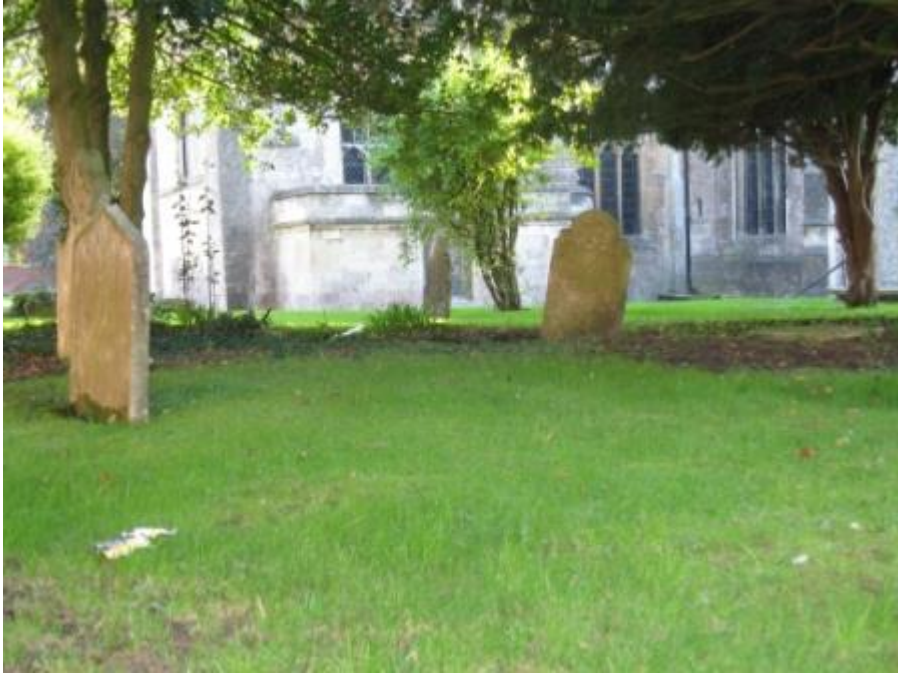
Note that the view of the church is obscured by the new growth of trees. There is no evidence of the wide path to the east of the church which appears to run downhill rather than uphill.

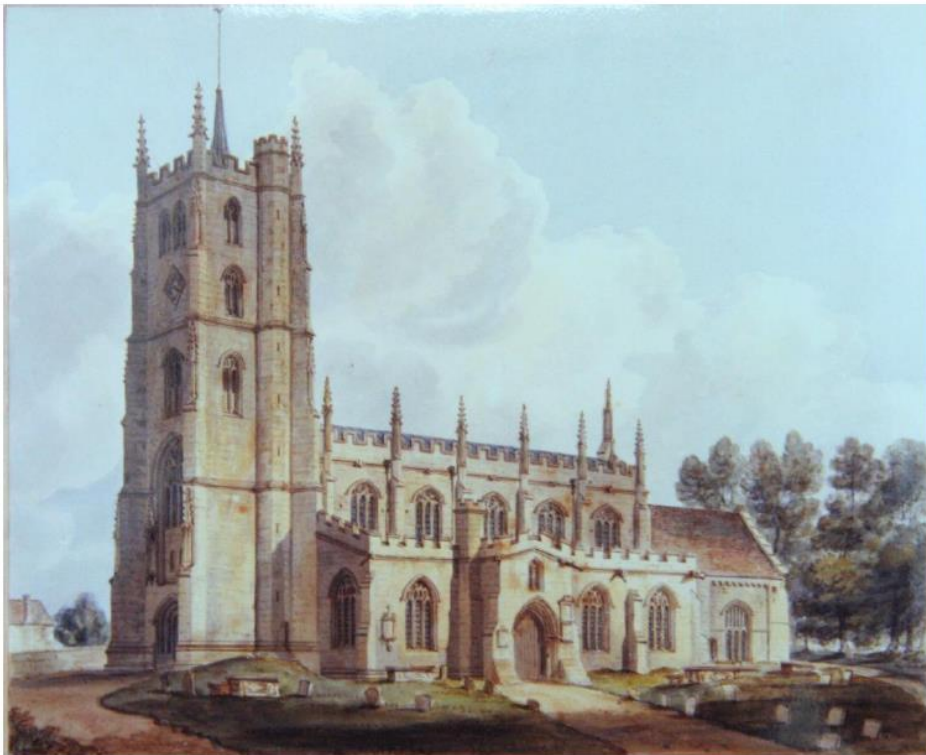
John Buckler's view of St. Mary's from the south west, 1805

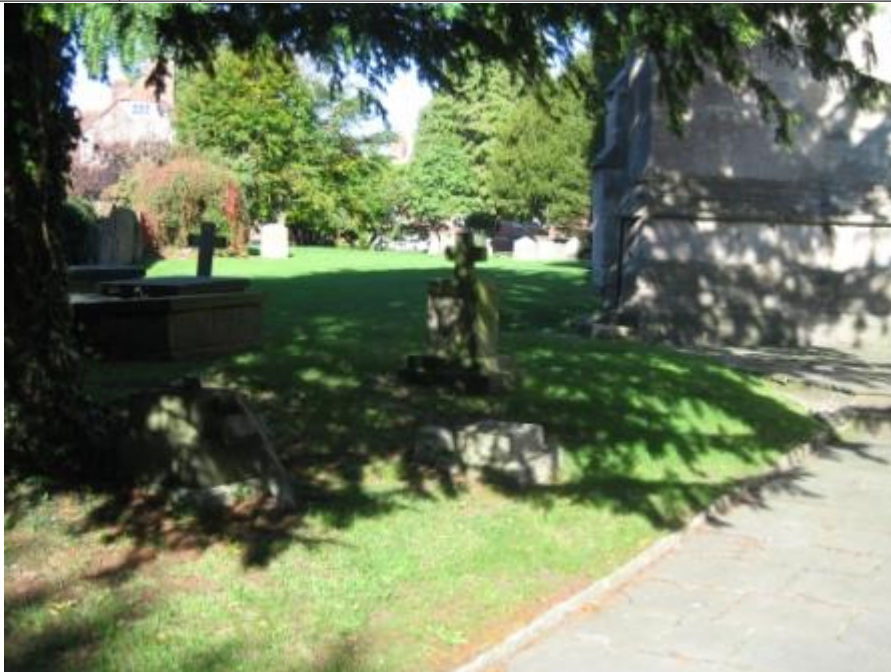
Note that the original view is no longer possible due to the extension into the churchyard by the Castle Public House. The old wide path has also disappeared, probably under the castle Hotel.

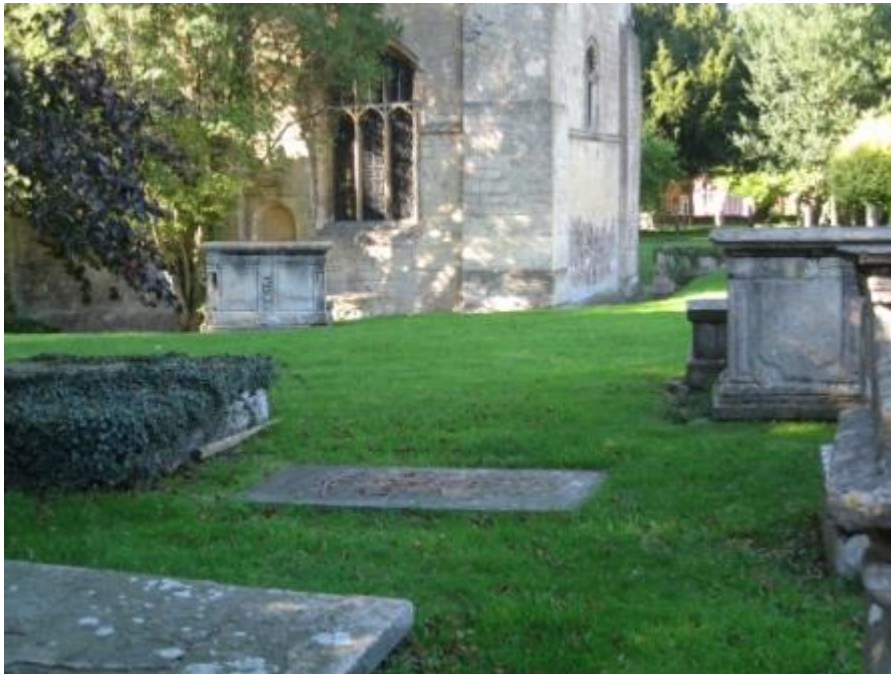
The original view is no longer possible due to the new trees. Also note that there seem to be no new grave markers in the view.
